ST. ALBERT FIRE HALL #1 FEASIBILITY STUDY

Prepared by

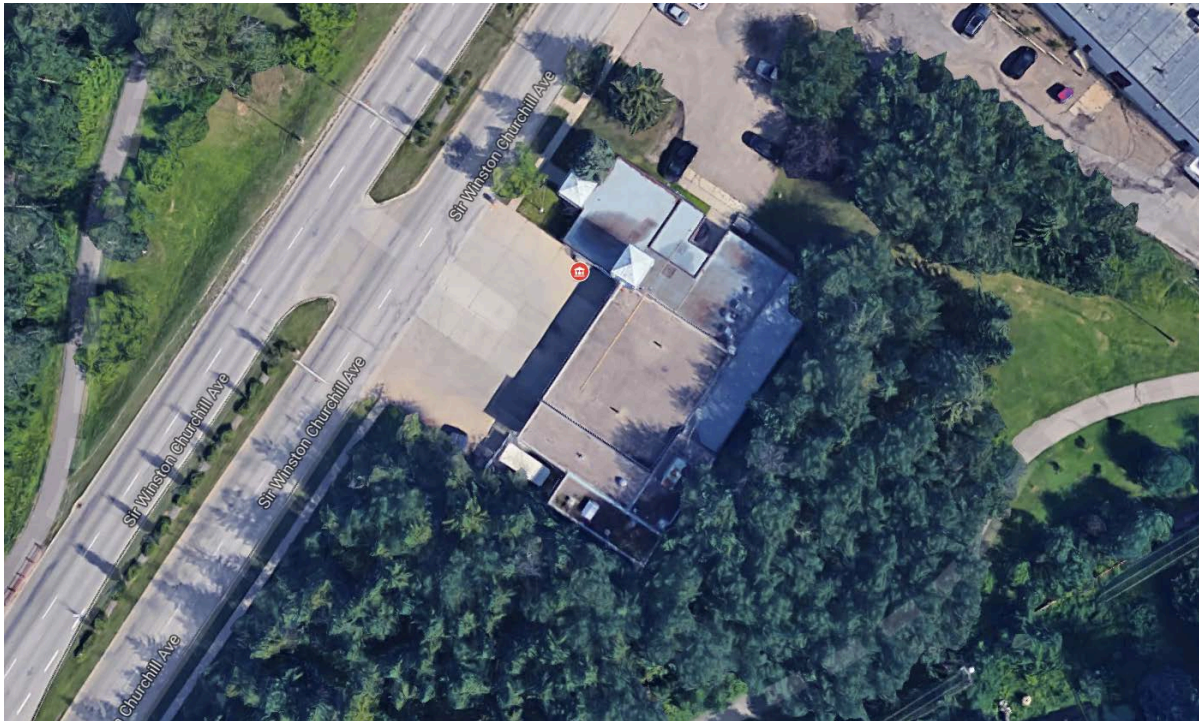
The fire hall #1 is located at 18 Sir Winston Churchill Ave. The most critical condition of the current site is its limited capacity of expanding. The site is surrounded by the heavily treed areas to the west, east and south, which would result in the back in-drive out of apparatus, not enough parking space, and poor visibility to the Sir Winston Churchill ave.

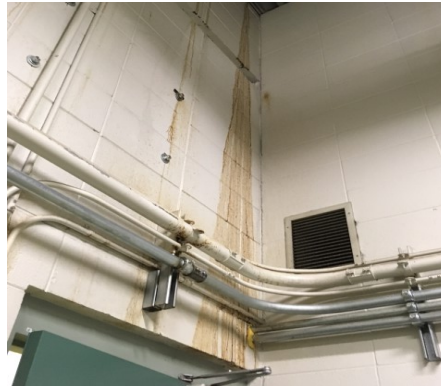
Photo 1: Roof leakage in generator room

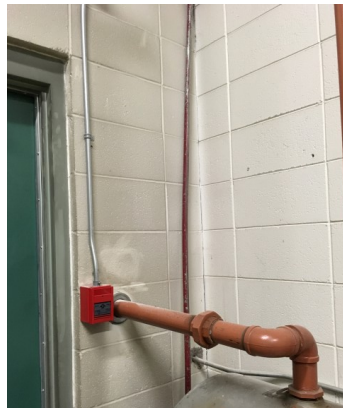
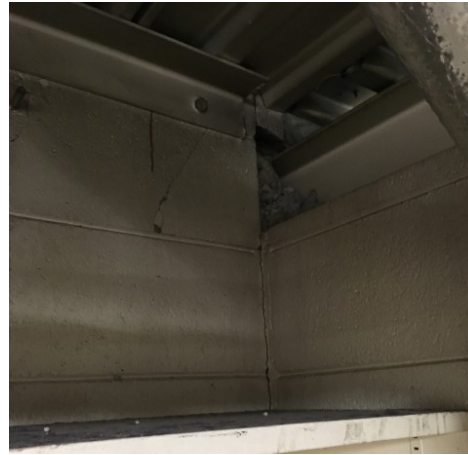
Photos 2 and 3: Typical cracks at masonry wall intersection

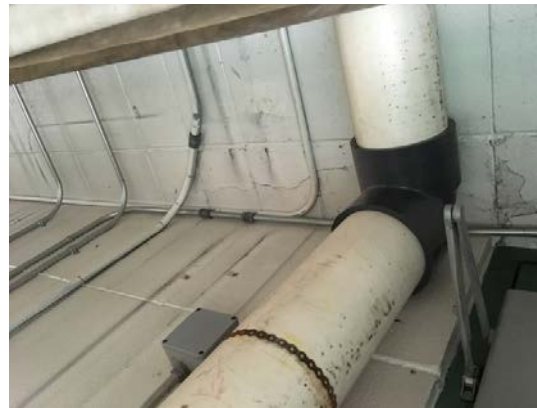
Photo 4: Cracking observed in hose tower masonry walls

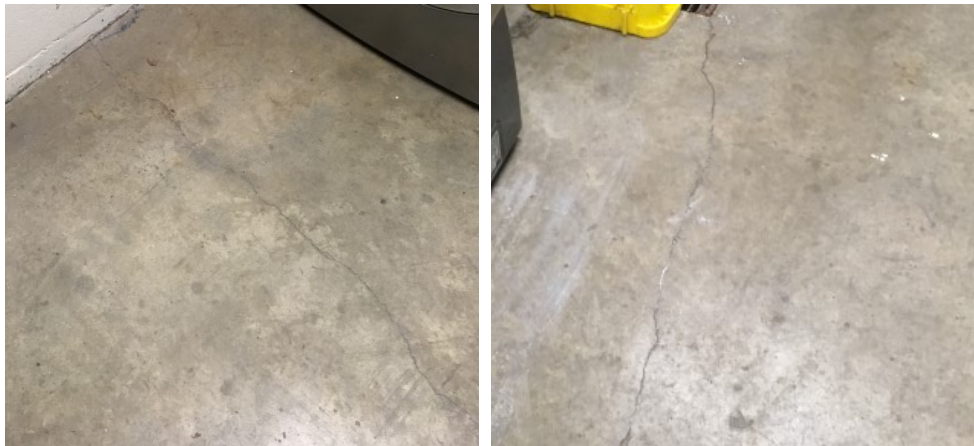
Photos 5 and 6: Typical cracks in slab-on-grade

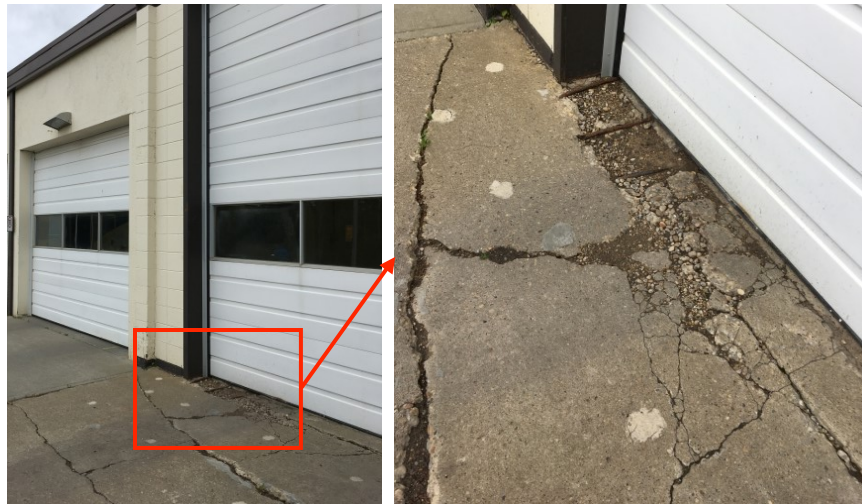
Photos 7 and 8: Apron slab deterioration at west overhead door

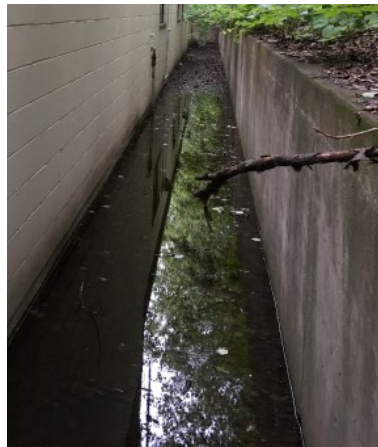
Photo 9: Sitting water on south side between retaining and foundation walls

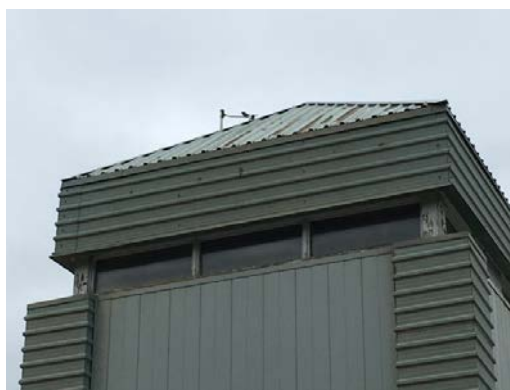
Photo 10: Deterioration of tower exterior finishes

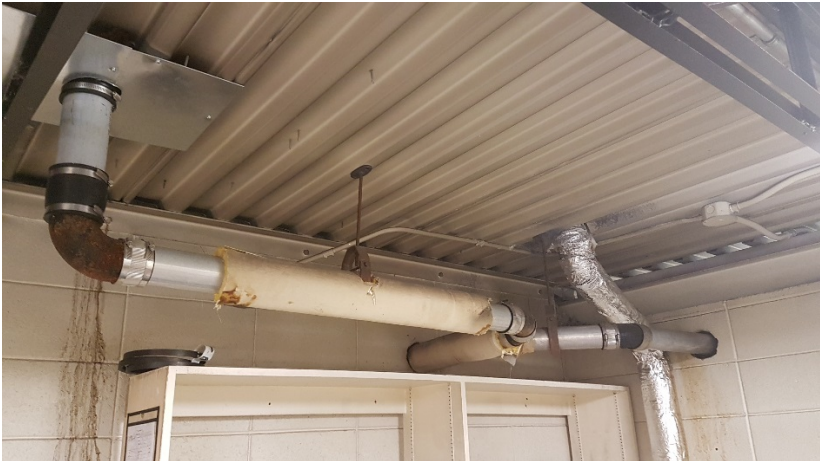
Photo 3 – Damaged & missing insulation on storm drains

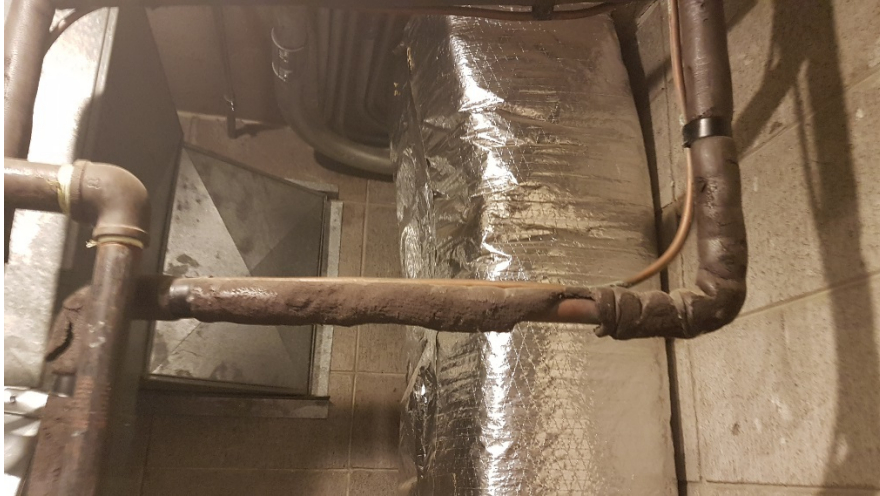
Photo 4 – Damaged refrigerant pipe insulation

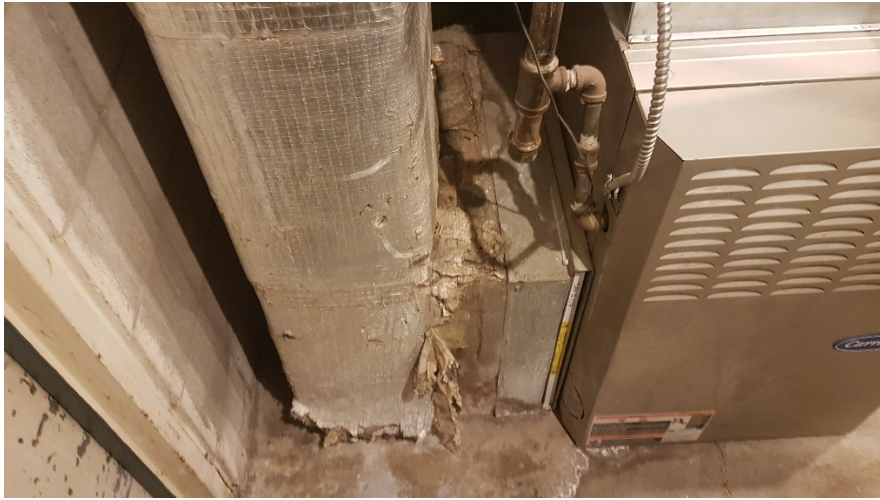
Photo 5 – Damaged duct insulation

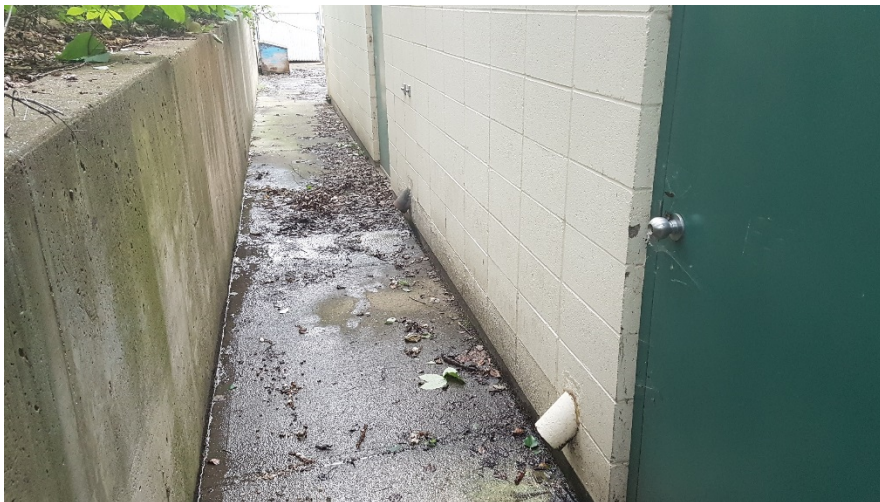
Photo 6 – Roof drains splashing to grade

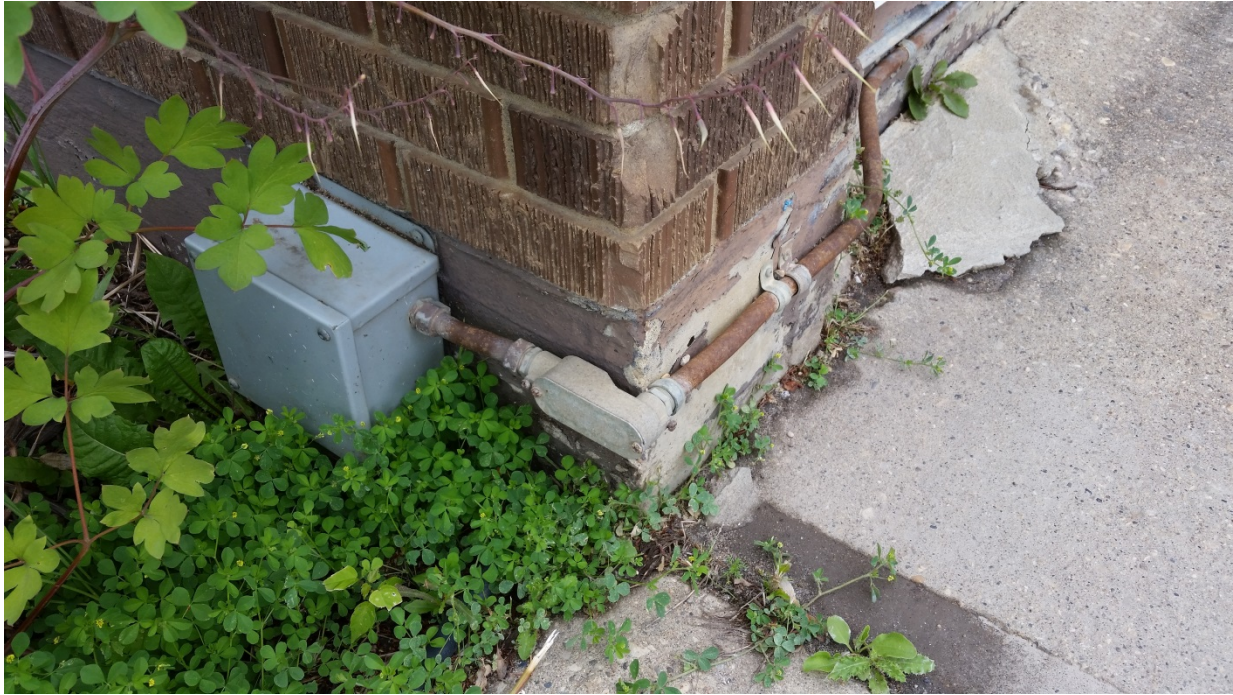
Photo 6 – Corroded exterior conduit

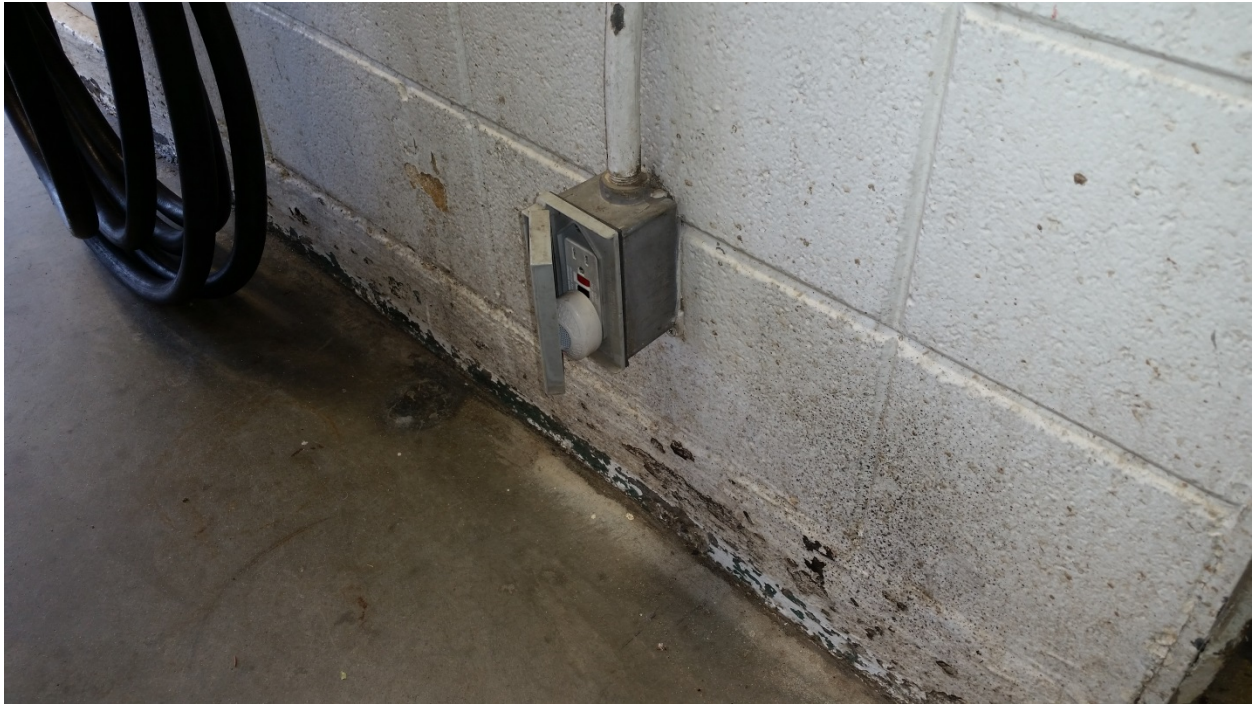
Photo 7 – Apparatus Bay Receptacle

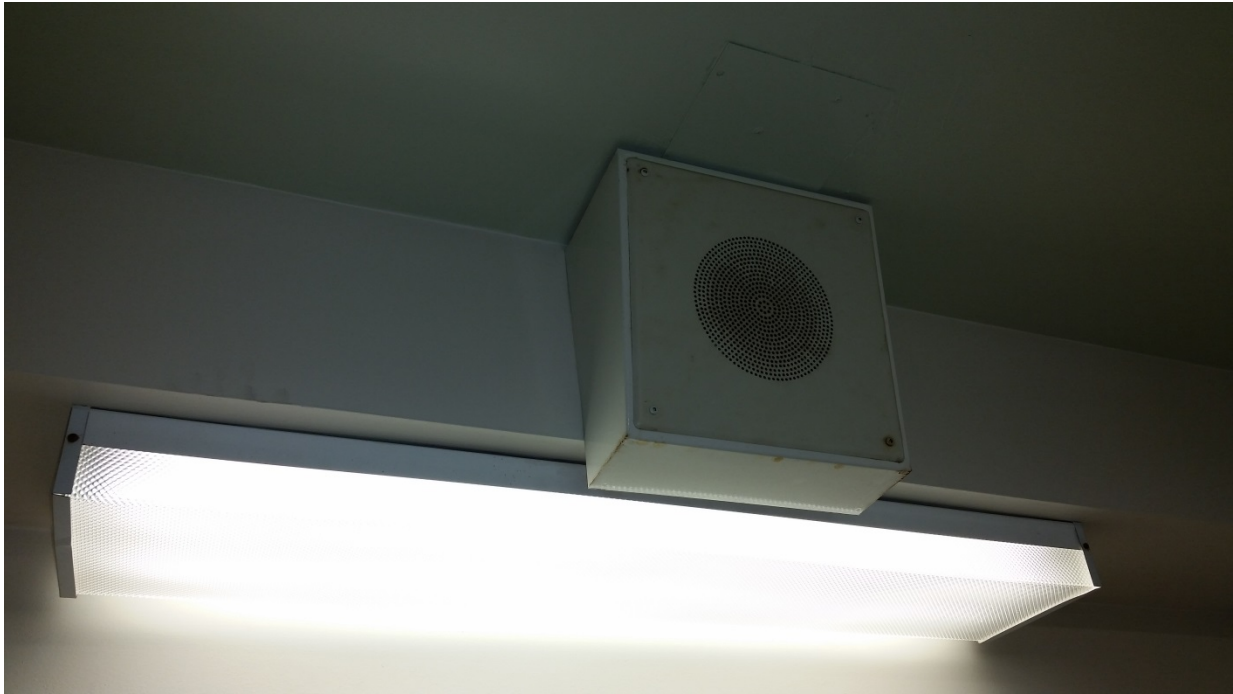
Photo 21 – Old Rusted Speaker

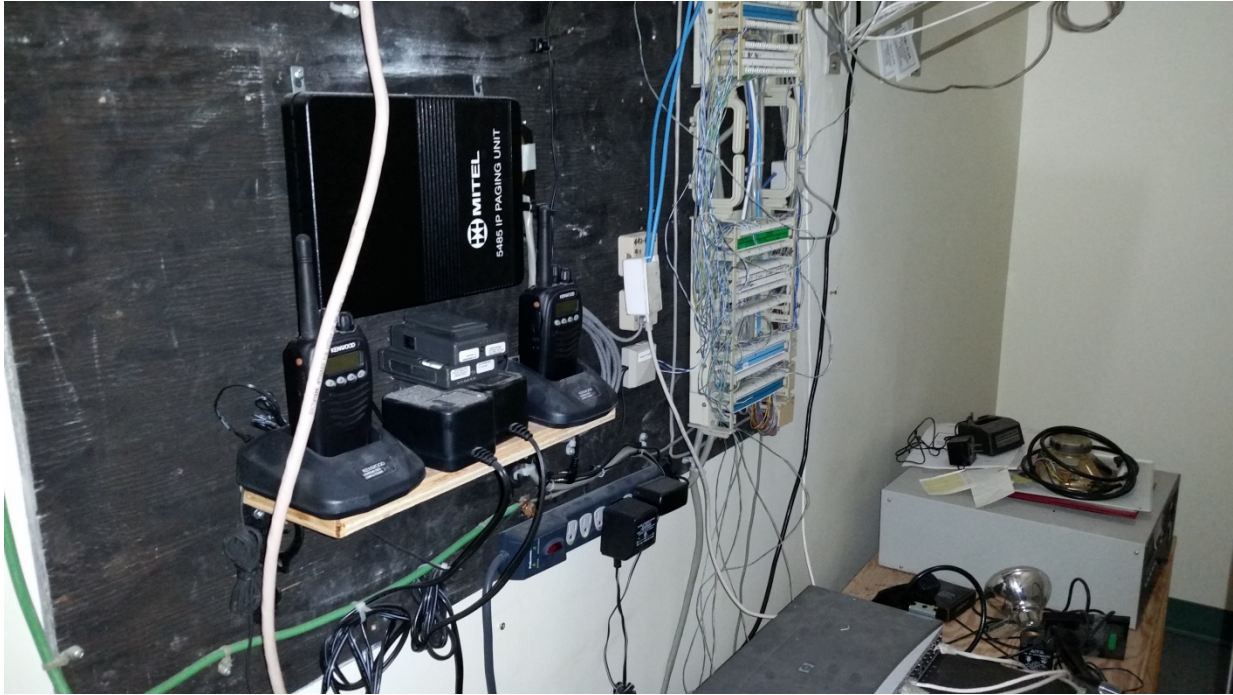
Photo 22 – Telephone Board
