Transportation Asset Management

Roads and Sidewalks in St. Albert

Date August 12, 2019

Brett Newstead P.Eng, M.Sc, PMP Transportation Infrastructure Engineer *City of St. Albert*

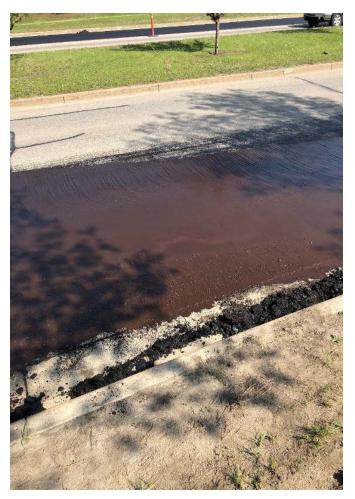
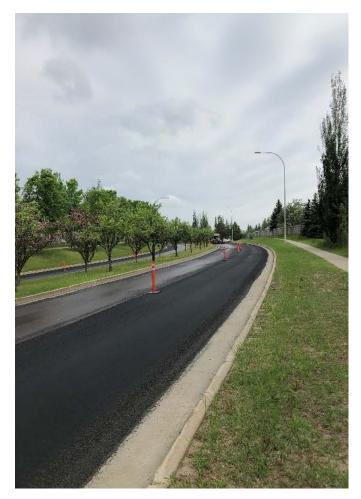
Microsurfacing on Bellerose Drive

- So why is the City using microsurfacing?
 - Cost efficient
 - Saves future funds
 - Extends pavement life
 - Increases friction
 - Decreases tire noise
 - Maintains current levels of service longer

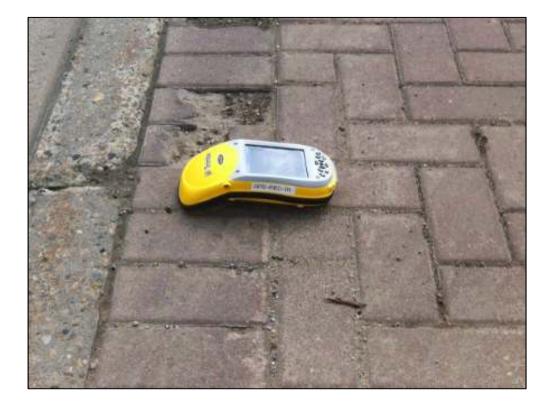
Sample Photo of Data Collector (2013)

- Foundation of current program
- Trimble GPS device
- Condition rating assigned to each street

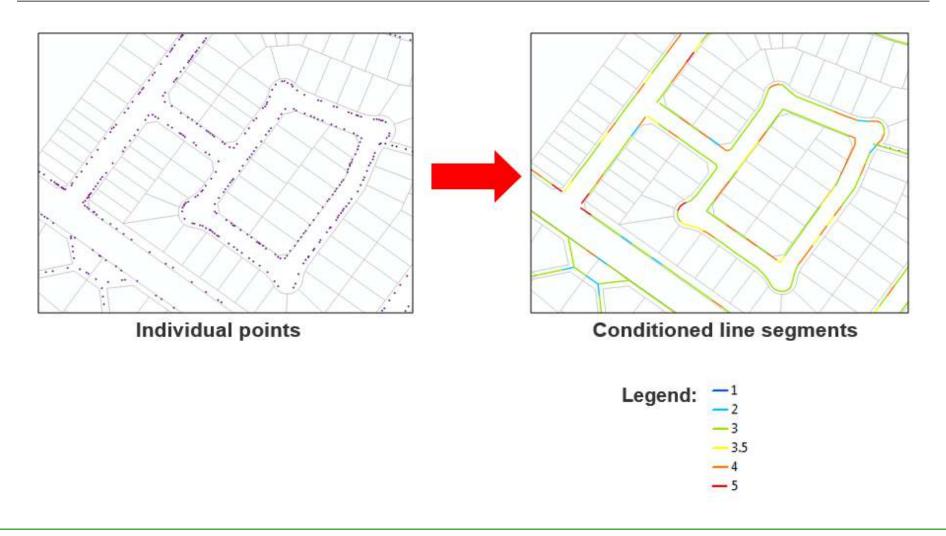
Sidewalks - Analysis

- Analysis
 - 10 meter sidewalk segments (6 panels)
 - Points grouped by nearest 10 meter segment
 - ArcMap points transferred to Excel
 - Algorithms condition rate (1-5) the segments
